Boulder Colorado

Buildings in Hazardous Zones

Chris Quinn
 April 9, 2007
 Advanced GIS Lab
 GIS 4890

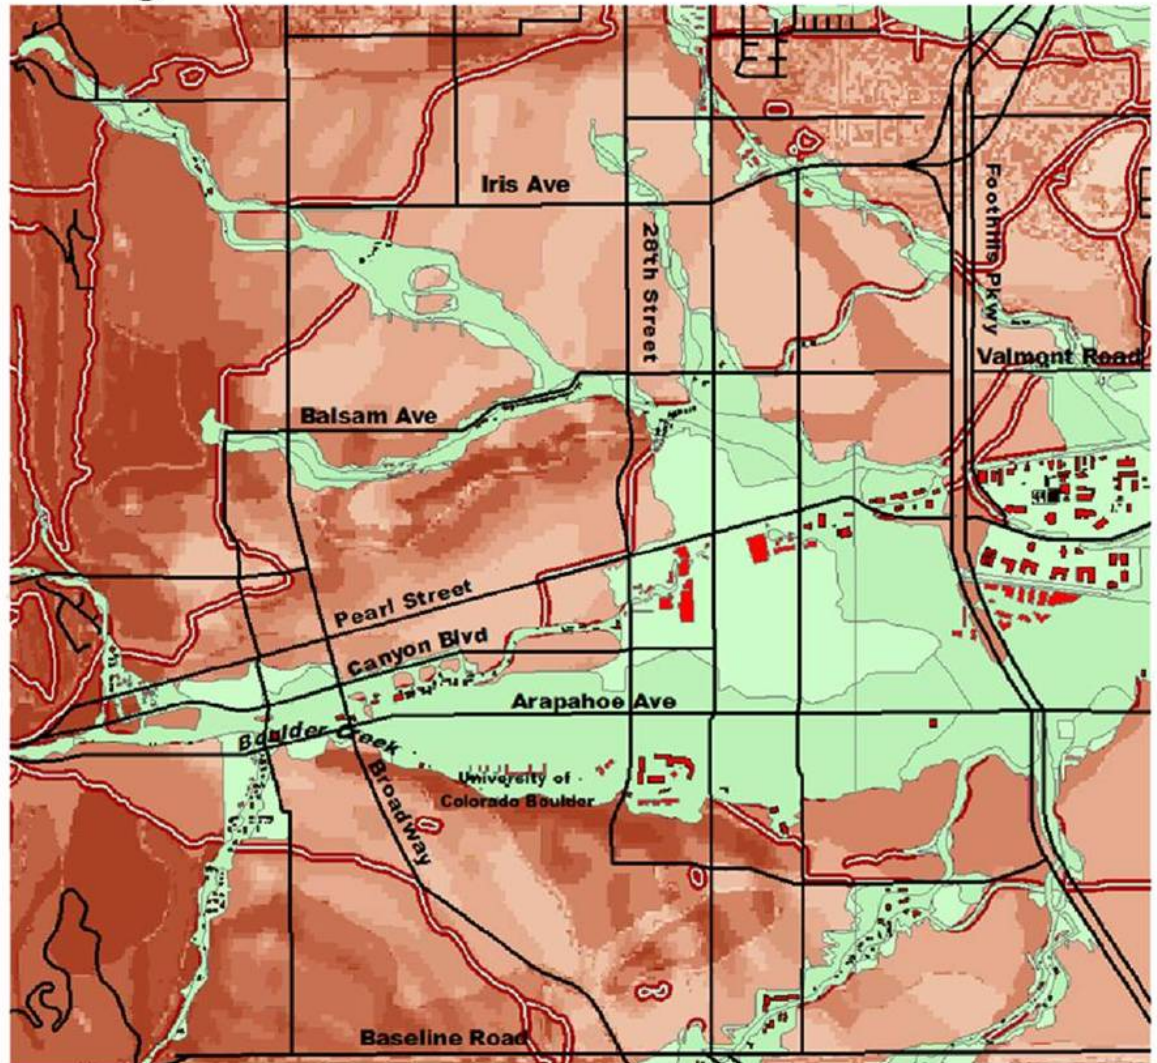
Map showing buildings built on unstable, unconsolidated, loose materials, that are within 100 and 500 year flood plains. Buildings indicated are at very high risk of severe damage during flood stages.
